Manhole Inspection Summary

Manhole # S29I__040MH

Insp Date: **9/8/08 2:14 PM**

Location Address: **105 Penn St**

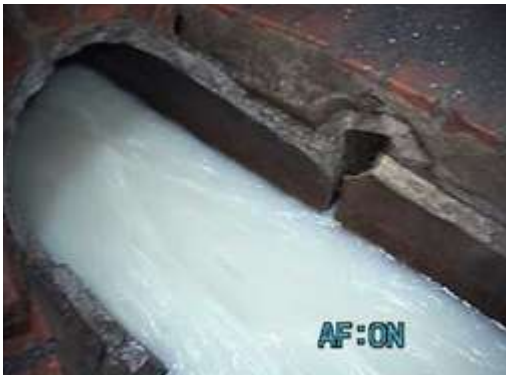
Defect 2

Condition: ☐ Sound ☒ **Cracked** ☐ Root Intrusion ☐ Deteriorated ☐ Leaks ☒ **Debris**

channel cracked

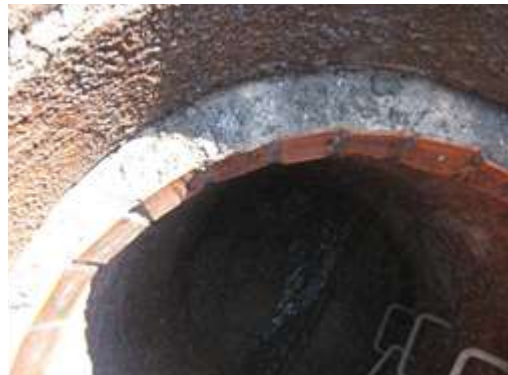
Defect 1

Offset: **3** (in.)

frame offst 3"

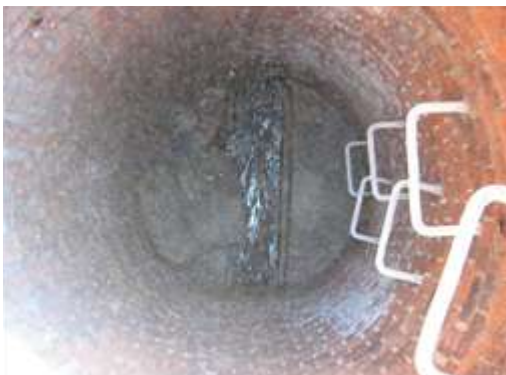
Defect 3

Condition: ☐ Sound ☐ Cracked ☐ Root Intrusion ☐ Deteriorated ☐ Leaks ☒ **Debris**

Bench debris

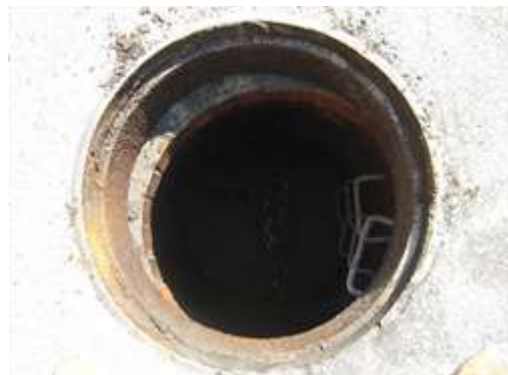
Defect 4

☒ **Leaks**

Frame leaks

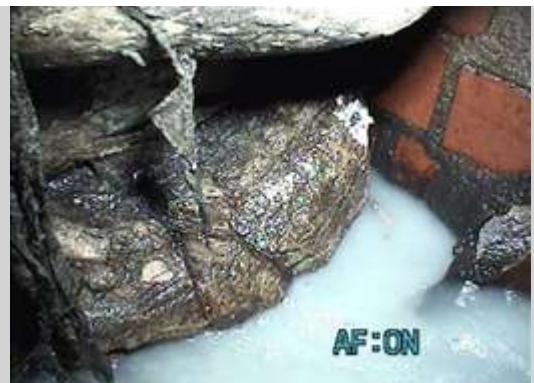
9 O'Clock Inflow

channel blocked
